Modification of cable for solve display issue 23.10.2019

European Service Dept.
2019.10.20

Door difference between before EC and after EC

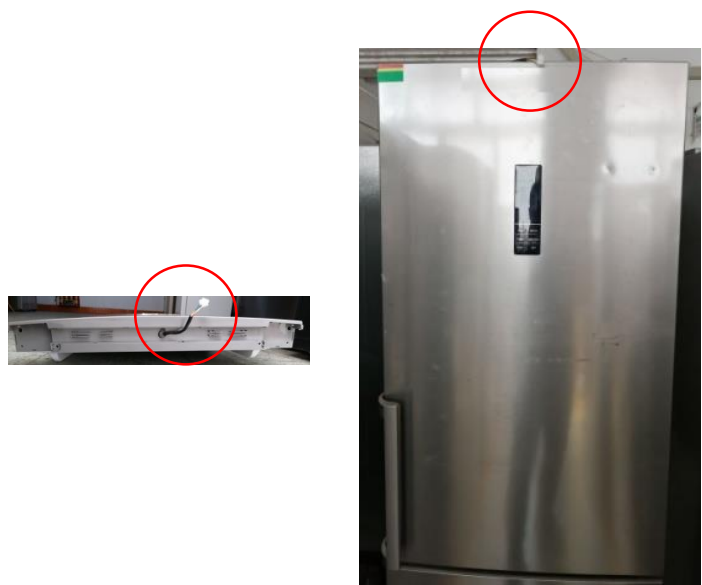
1. The above front view and top view show the difference between Before EC and after EC;
2. Because of the different location of connection cable for display panel, The two refrigerator doors for before EC and after EC are different and incompatible;
3. The refrigerator door before EC share the same part code with the refrigerator after EC. It is really difficult for market to manage the same part with two different status. Please make ref. to the above information to check the repair case is before EC or after EC.

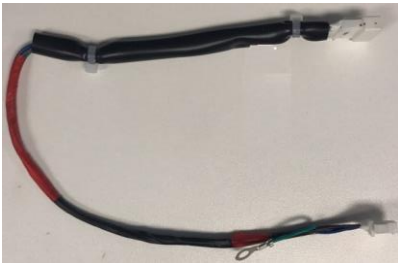
Close up for the cable change of the appliance before EC

1. The appliance before EC still use the display connecting cable(1495740) and the appliance after EC cancel the cable ;
2. The Appliance before EC often have the issue of display connecting cable(1495740) . You can change the original connecting cable (1495740) to fix this issue and also you can use alternative cable (2025391) to fix this issue. But you should follow the following instruction to change some relative part.

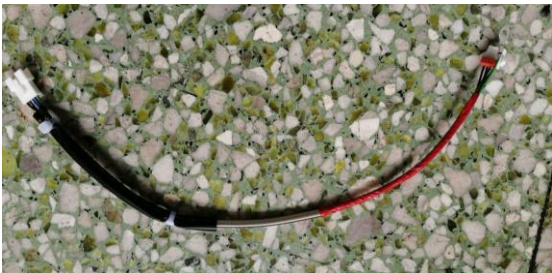
旧的连接线 (1495740)
The connecting cable (1495740)

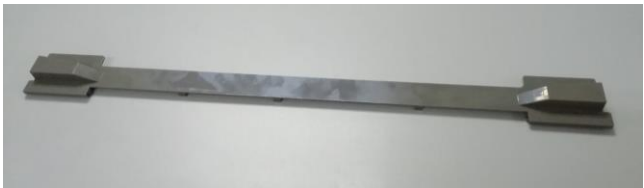
旧的端盖盖板
The upper cover before EC

物料号 Part No.	1468424 (gray)
	1493865 (White)
	1617800 (black)

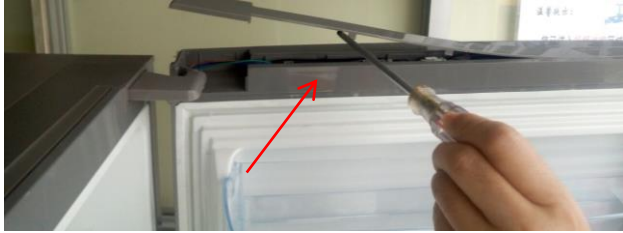
新的端盖盖板
The upper cover after EC

物料号 Part No.	2019468 (gray)
	2019466 (White)
	2019470 (black)

1. 拆下门体上盖板 disassemble the upper cover of upper door

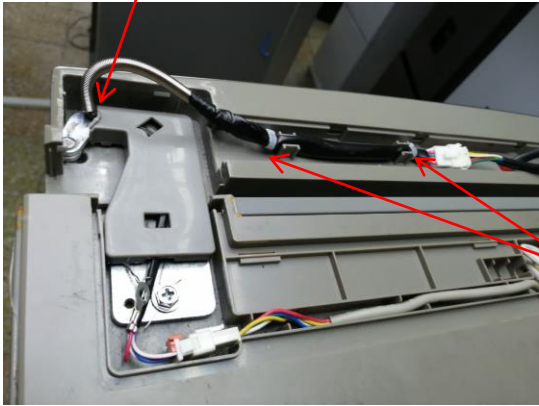
新连接线 the new connecting wire(2025391)

◆ 2条扎带必须固定在卡槽两侧 These two straps must be located on both sides of the mounting slot

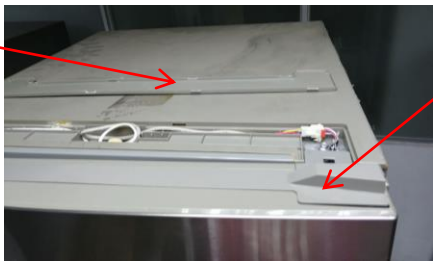
顶盖板 the top cover

端盖盖板 The new upper cover of upper door

gray	2019468
white	2019466
black	2019470

5.安装新的端盖盖板 cover the new upper cover of upper door
